Corrugated stainless steel tubing, or CSST, is a flexible pipe used to supply gas in homes and businesses.

Important **Safety** Information

**Do you have this type of
gas piping in your home
or business?**

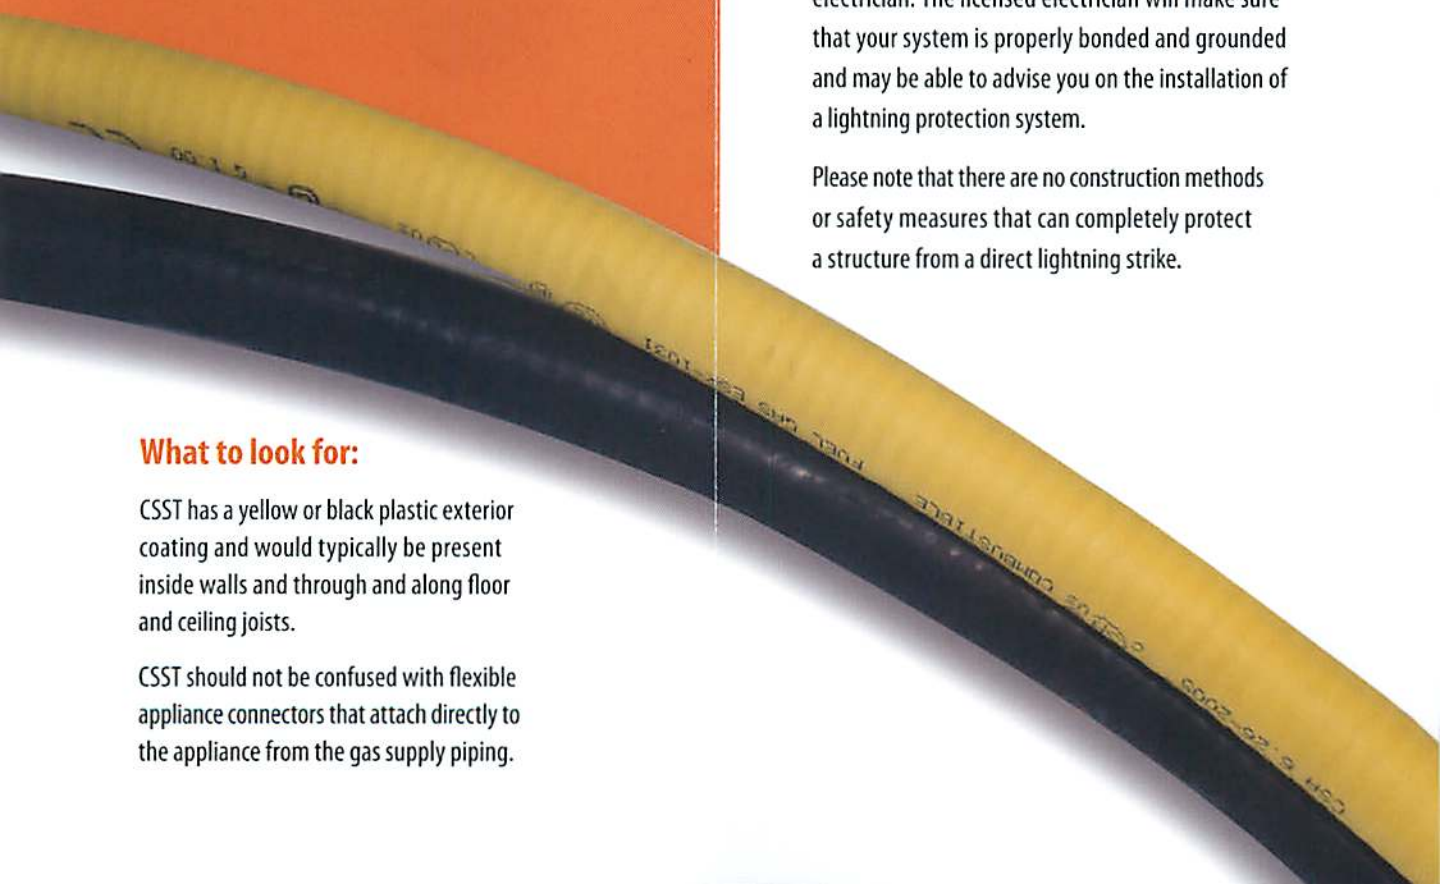
CSST has a yellow or black plastic exterior coating and would typically be present inside walls and through and along floor and ceiling joists.

CSST should not be confused with flexible appliance connectors that attach directly to the appliance from the gas supply piping.

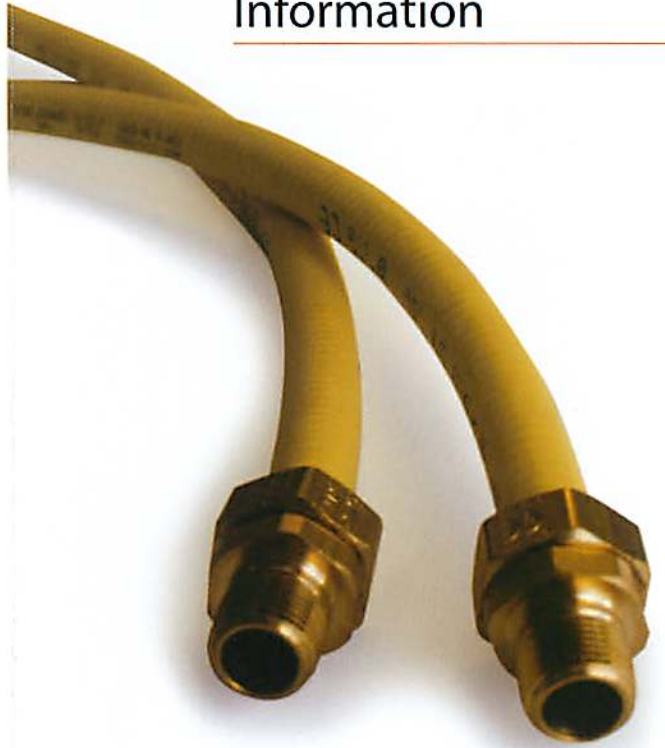
If so, a lightning strike at or
near your structure can create a
potentially hazardous situation.
